North and South Riga Ponds 2023 Monitoring Report

Prepared for the Riga Environmental Stewardship Committee

March 8th, 2024

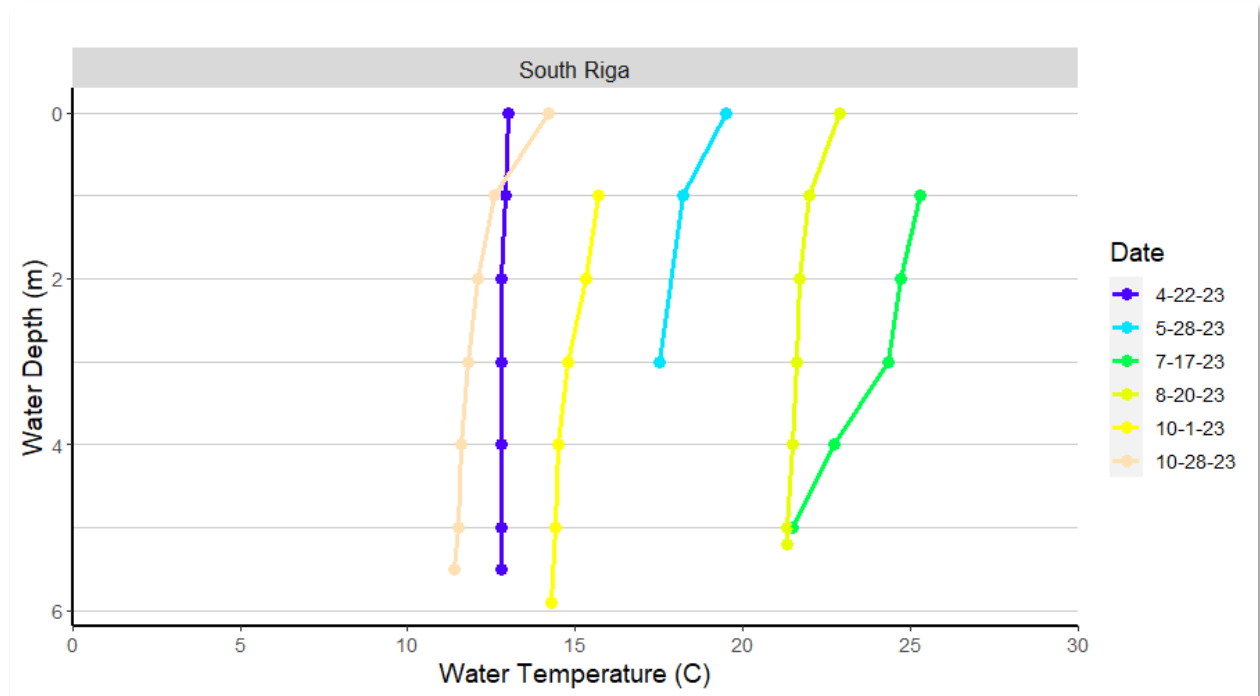
Figure 4. Temperature profiles at South Riga in 2023.

Volunteers collected six temperature profiles in South Riga in 2023 (**Figure 4**). The lake was isothermal (similar temperature from surface to bottom) in April, after which the lake warmed until July. The May 28th profile was incomplete and missing data at select depths. By October 28th, the surface waters were warmer than the bottom and the lake was isothermal from 3 meters to the bottom. Data loggers were also deployed in South Riga from early September to mid-November.

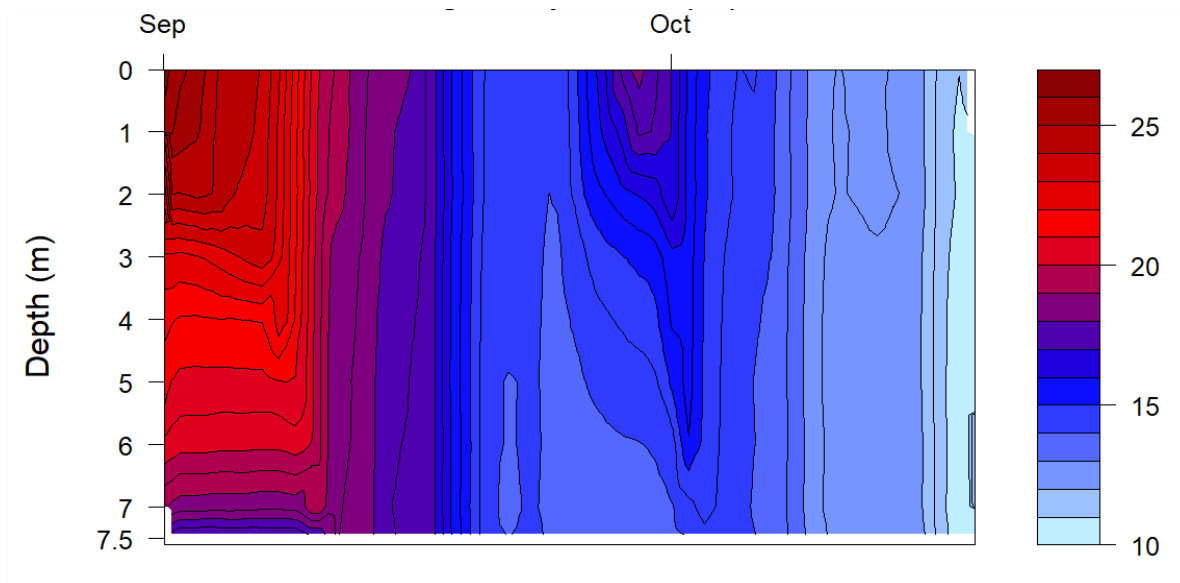
Figure 5. Water temperature isopleth for North Riga, September 7th-October 25th, 2023.

effectively display high frequency temperature data, NEAR staff created temperature isopleths for North and South Riga. North Riga was isothermal (same temperature from surface to bottom) by mid- to late-September (**Figure 5**). In early October, a brief warm-up occurred but the lake was isothermal by mid-October and continued to cool. All of the data loggers in North Riga, except for the bottom, did not record temperature beginning in late October. We have observed this with other data loggers in the past, but it is unknown at this time why the loggers stopped recording. For the isopleth at North Riga, we removed the bottom data from October 25th-November 10th to keep the data consistent.

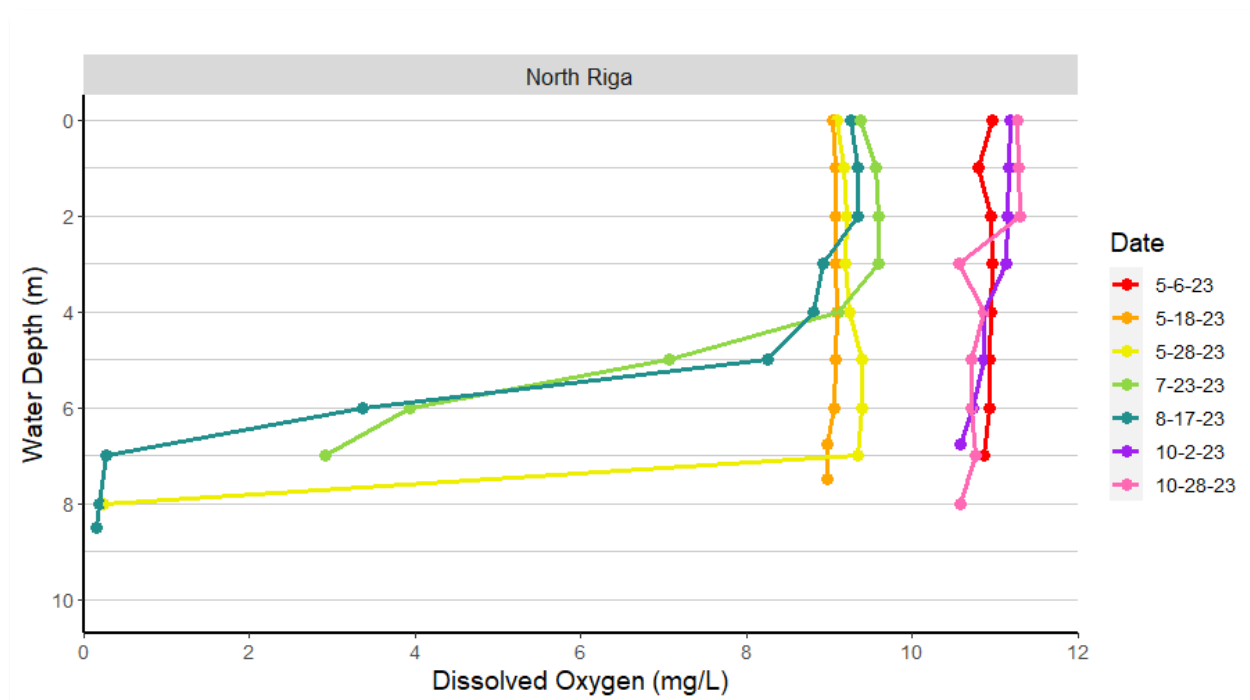
Figure 7. Dissolved oxygen profiles at North Riga in 2023.

Dissolved oxygen (DO) concentrations in North Riga in May remained fairly consistent from the surface to the bottom of the lake (**Figure 7**). By May 28th, the very bottom water at 8 meters was anoxic. By July 23rd, there was a sharp decrease in DO from 4 meters to the bottom. In October, DO was replenished in the lake.

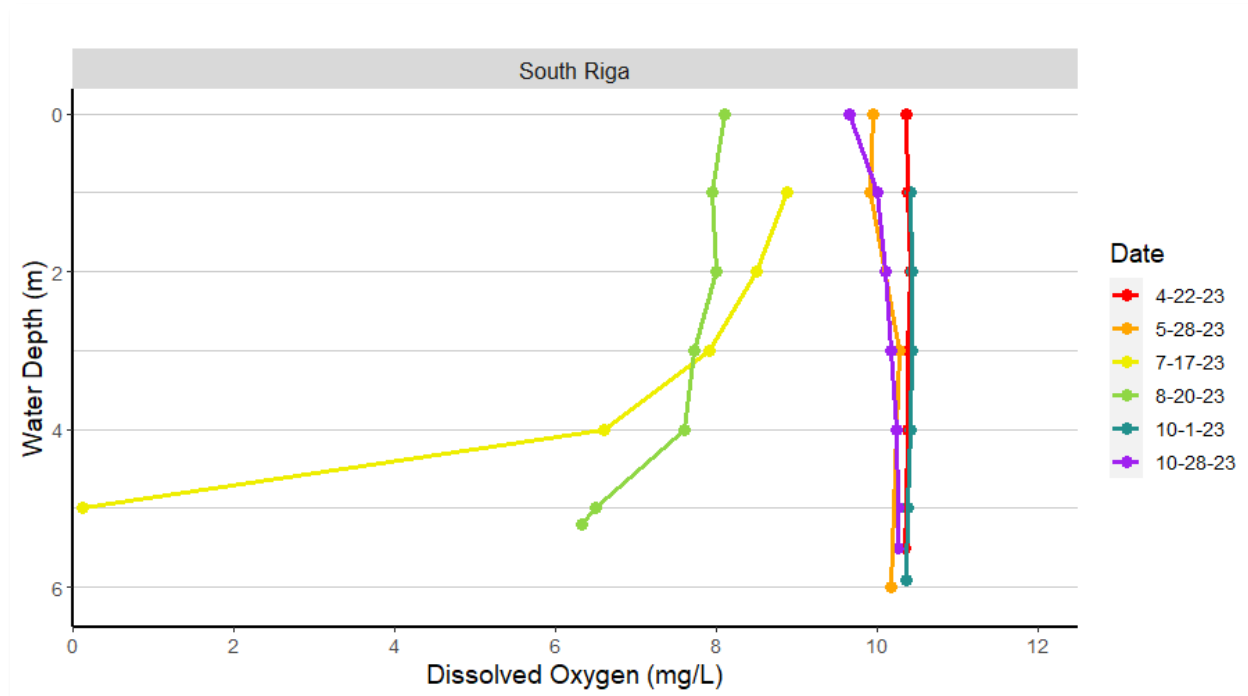
Figure 8. Dissolved oxygen profiles at South Riga in 2023.

DO followed a similar pattern in South Riga (**Figure 8**). In April, May, and October, DO was fairly consistent from surface to bottom and there was no anoxic water. In July, there was a sharp decline in DO from 4 meters to the bottom at 5 meters. In August, DO was replenished and approximately 6 mg/L at the bottom of the lake.

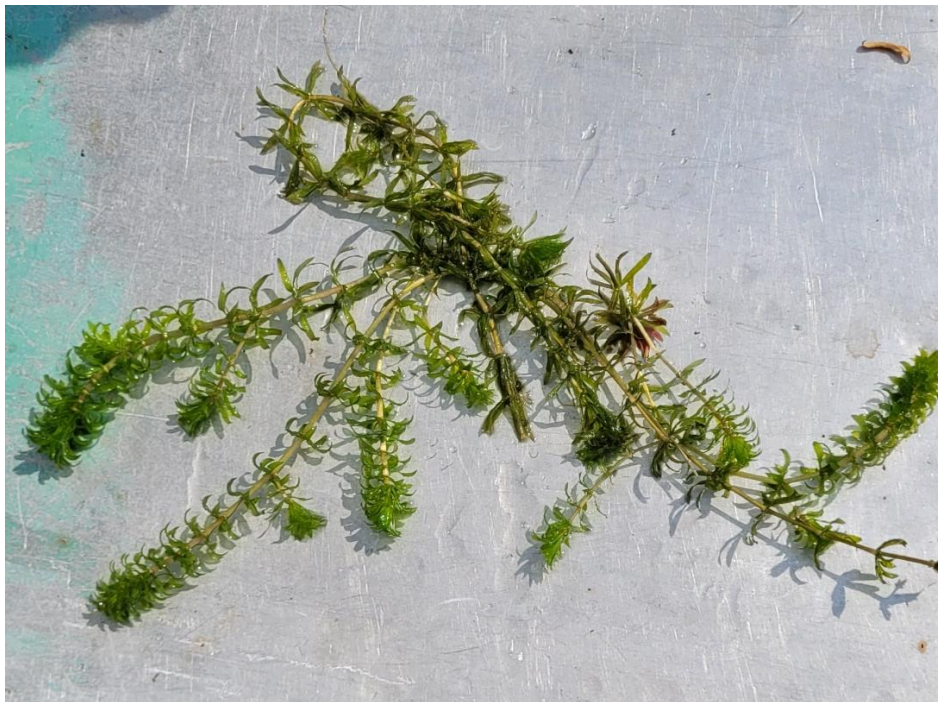
Hydrilla from East Twin Lake, July 2023

- The rampant invasive aquatic plant *Hydrilla verticillata* is actively being transported to lakes in CT from the CT River. NEAR found an infestation of Hydrilla in nearby East Twin Lake in 2023. We strongly recommend that MRI institute a boat sticker program where all vessels that use the lakes are inspected and given a prominent sticker that marks the vessel as clean. No vessels or fishing gear should be allowed near the lake until inspected.
 - a. More information can be found on Hydrilla at the Connecticut Agricultural Experiment Station website: <https://portal.ct.gov/CAES/OAIS/Connecticut-River-Project>
