# North and South Riga Lakes

## 2018 Monitoring Report

Salisbury, CT

**Northeast Aquatic Research**

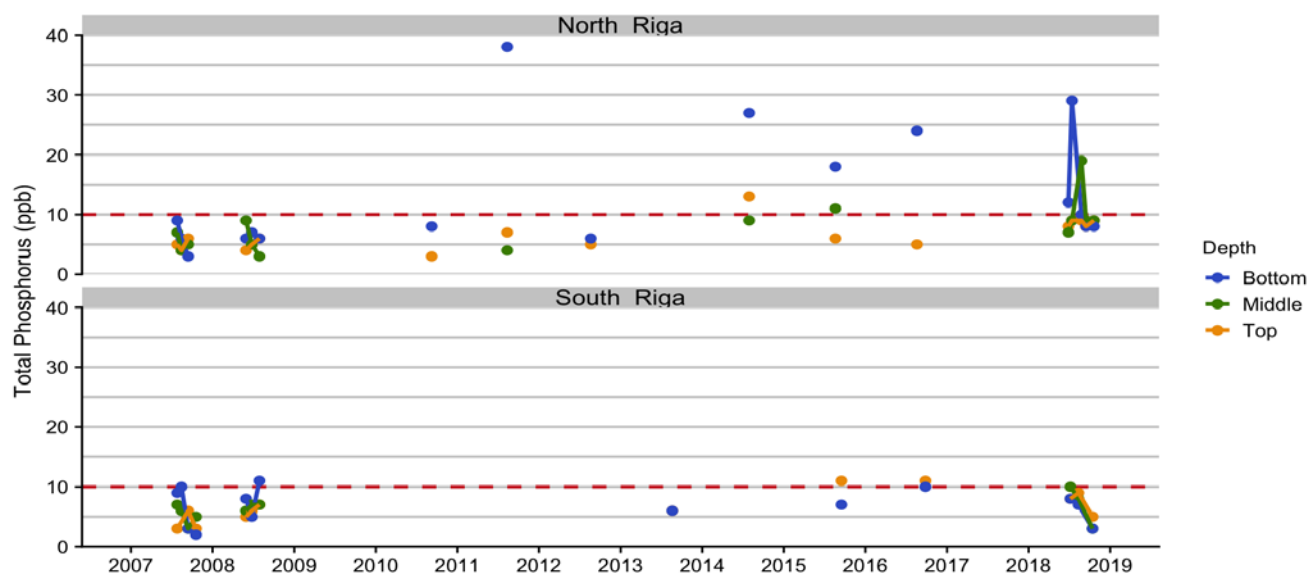
Figure 7 – Phosphorus trends at North and South Riga Lakes

2018 was the first year since 2007-2008 that water samples were collected monthly for the duration of the summer season. From 2008 through 2016 (monitoring was not conducted in 2017), water samples were collected either once each year, or once every other year. Water samples are collected from three depths because of the potential for a concentration gradient to exist between the bottom and top of the water column. As stated above, phosphorus can be liberated from bottom sediments when the water over the sediments becomes anoxic. Data from 2007-2008 showed no loss of oxygen at the bottom and subsequently no increased phosphorus at the bottom. 2011 was the first year that we found phosphorus accumulating in bottom waters (**Table 4**). Beginning in 2013, increased phosphorus in bottom water has occurred each year the lake has been sampled (**Figure 7**).

North Riga phosphorus at the top and middle depths has also shown an increase over the time we have been sampling the lake. In 2007-2008 phosphorus at top and middle depths ranged between 3ppb and 9ppb, with an average of 5.2ppb. In 2018, phosphorus in top and middle depths ranged between 7ppb and 19ppb with an average of 9.6ppb, a doubling of average phosphorus content in the lake. South Riga has not shown the same doubling of phosphorus concentration; rather levels have not changed appreciably since early sampling in 2007-2008. In South Riga, average phosphorus changed from 5.5ppb to 7.2ppb between 2008 and 2018.

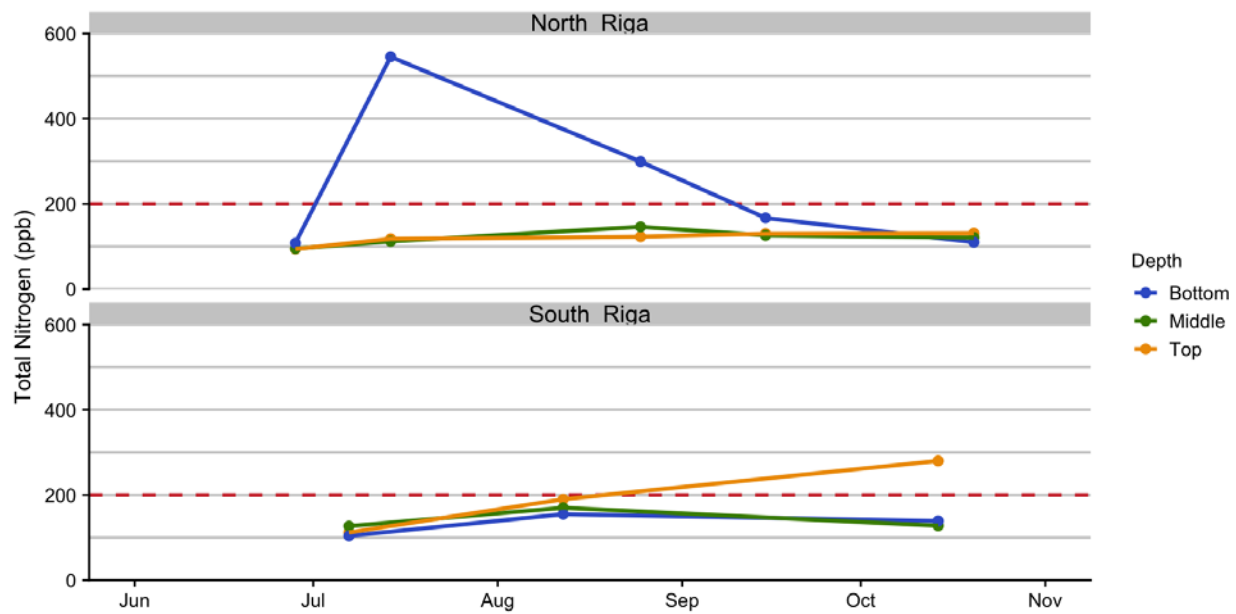
**Figure 9** - *Total nitrogen results from the top, middle, and bottom depths at North Riga and South Riga, 2018*

Total nitrogen (TN) includes fractions of nitrate, ammonia, and organic components. Ideally, TN should remain below 200 ppb, to keep the lake in the 'oligotrophic' category (**Table 1**). At North Riga in 2018, TN remained low in top and middle samples (**Figure 9**). In the bottom water, TN was low in June but by mid-July it had spiked to 545 ppb concurrent with the bottom phosphorus increase. The 545ppb result is the highest concentration of TN on record for North Riga (**Table 5**). By August, TN had decreased, but

was still somewhat elevated at 299 ppb. In September and October, TN had fallen back below the 200 ppb threshold.

At South Riga, TN was low in July and August, remaining below 200 ppb. In October, TN was low at the middle and bottom of the water column, but reached 280 ppb in the surface water. In August, TN was also highest at the top of the water column. This suggests that nutrients are entering the lake from the watershed, by way of inlets and/or groundwater seeps. It would be beneficial to conduct an analysis of the watershed to determine the main sources of nutrients entering the lake.

1. Continue the in-lake water quality monitoring, ideally from April through October and maybe November at North Riga, to track the full extent of seasonal fluctuations, including peak extent of anoxic water, best and worst seasonal clarity, and peak nutrient concentrations.
2. Collect inlet samples from all flowing inlets in May and test the samples for total phosphorus, total nitrogen, and nitrate nitrogen.
3. Conduct a late-season full-lake aquatic plant survey to document the presence and abundance of aquatic plant species in the lake and to search for invasive species.
